THE FLIPPIN' MOTORBIKE

A Case Study in Failure Analysis

A study of the chain of events leading to the blowout of a tire in a Benelli 125 cc motorcycle which had been operated for about 2500 miles. Fixation of the cause of the blowout was necessary since the passenger was injured and entered suit against the owner-operator.

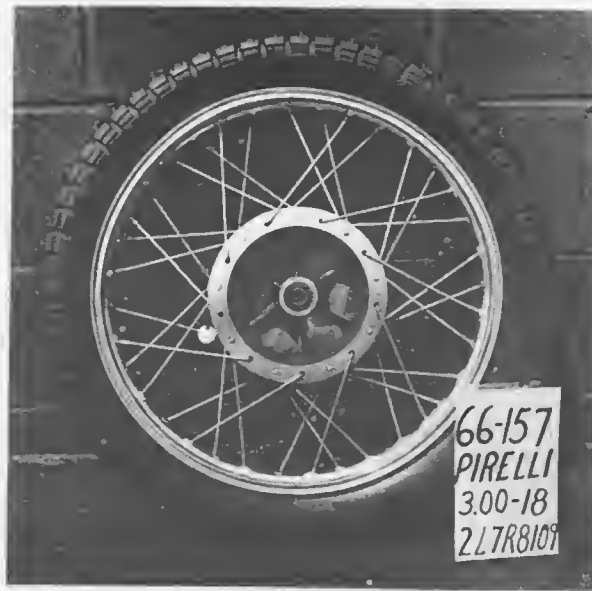
Figure 1

Right Side of Failed Tire Mounted on Rear Wheel

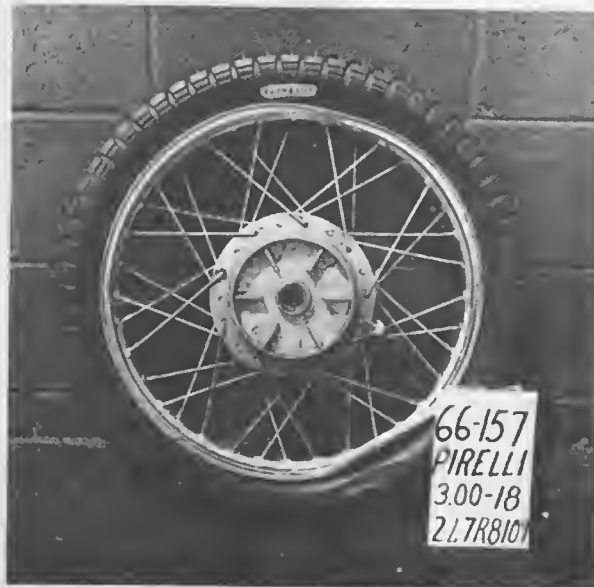
Figure 2

Left (driven) side of failed tire mounted on rear wheel. Note section of rim separated from rest of wheel (at bottom) as well as abraded region on the tire. Note also the deformation of the rim (at the top) in the vicinity of the valve stem.

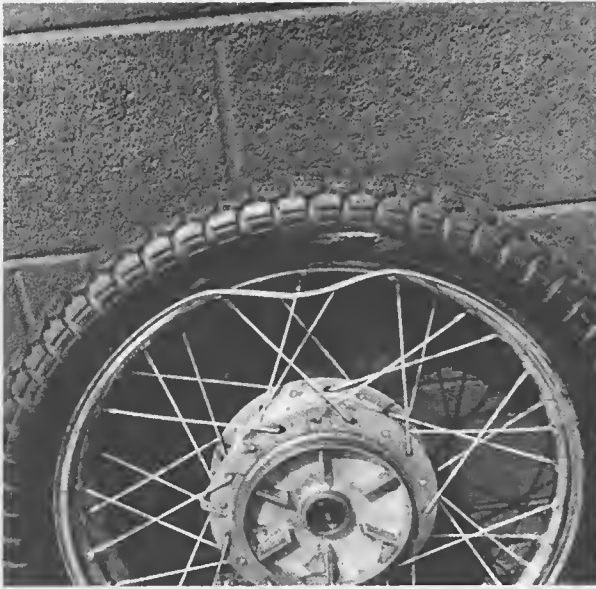
The right side of the rear wheel is shown in Figure 1 and the left side in Figure 2. Figure 3 shows a closer view of the blowout region of the tire and a separation of part of the rim from the rest of the wheel. The motorcycle dealer commented that this separation in the rim was in the same place as the crack or blemish which had been observed earlier. It was observed that the hole in the inner tube which failed was a simple tear with rubber missing in the shape of an oval, approximately 1/2 in. long, 1/4 in. wide.

A Closer View of the Separated Rim and Abraded Portion of the Tire.

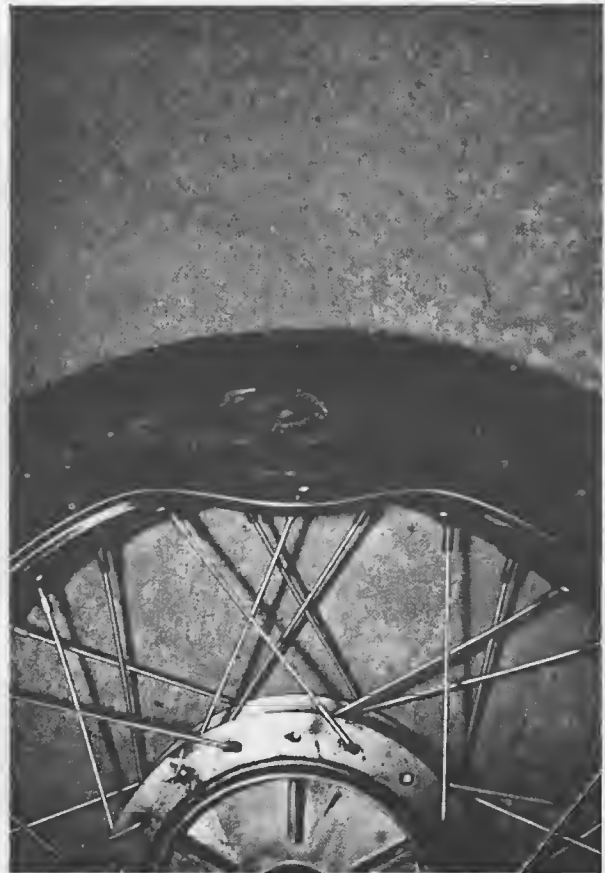
Figure 4 shows the tire mounted on the wheel with a new inner tube. After inflation with a hand pump, a "bubble" can be seen in Figure 4. The purpose of this test was to determine whether the inner tube would bulge out between the tire bead and the rim flange where the flange had separated from the rim base or

whether the inner tube would bulge out through the abraded hole in the tire sidewall. At a pressure of 26.5 psi, the tire bead had been forced off the bead seat but the inner tube did not bulge out at that point. Rather, the inner tube was bulging through the hole in the tire sidewall. At a pressure of 42.2 psi, the inner tube was still not bulging out where the bead was off the seat of the rim and the bubble was sticking out of the abraded hole in the sidewall by about 1/2 in. A further increase in pressure by about 5 psi burst the bubble. The appearance of the hole in this inner tube was quite different from that in the accident inner tube. The burst hole was star-shaped with a small piece of rubber (about 1/8 in. diameter) missing at the middle with cracks or tears radiating from this small hole.

A View of the Failed Tire Mounted on the Wheel with a New Tube which has been Inflated. (A "bubble" of the new tube can be seen protruding through the break in the wall.)

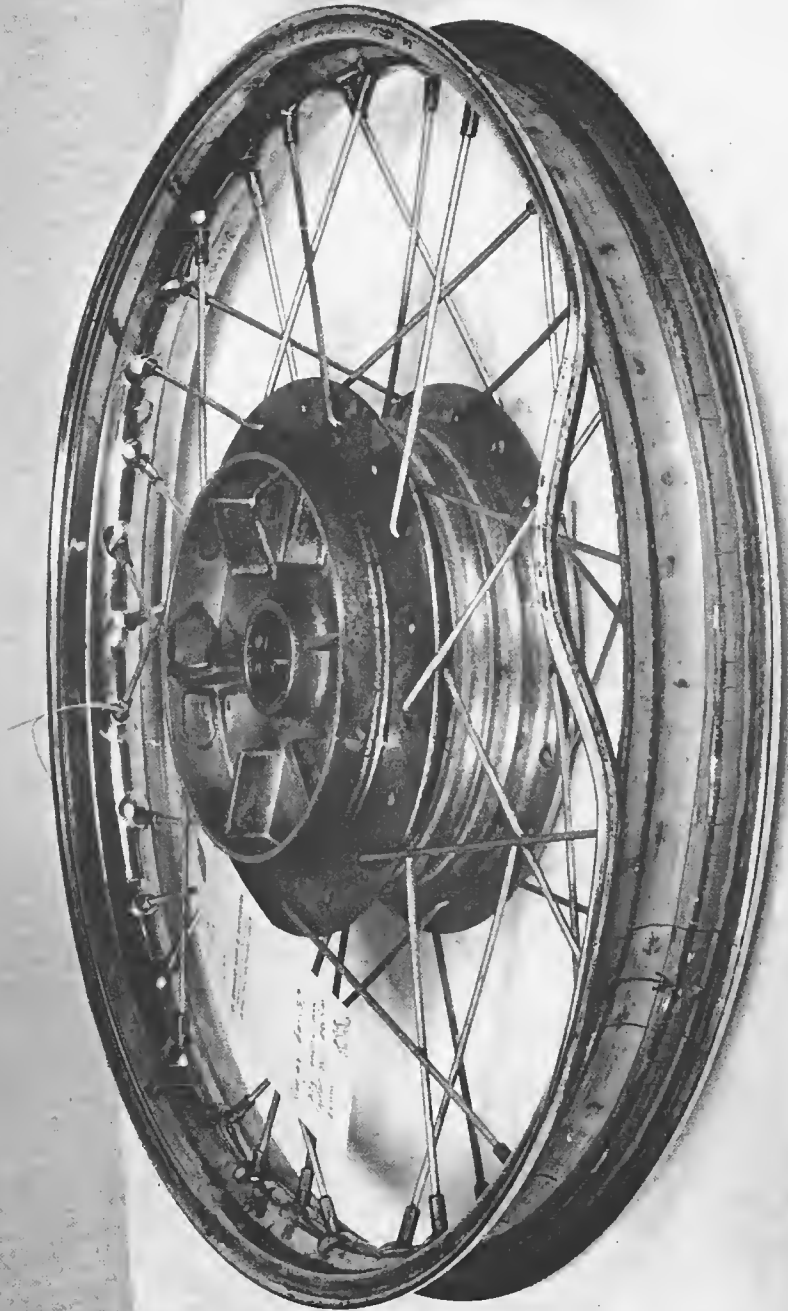
Figure 5 shows the wheel with the tire dismounted. The separation of the flange from the rim base is obvious.

Overall View of the Motorcycle Wheel Showing the Left (driven) Side.
(Separation of the rim from the rest of the wheel is obvious. The
arrow in the rim indicates the position of a weld.)

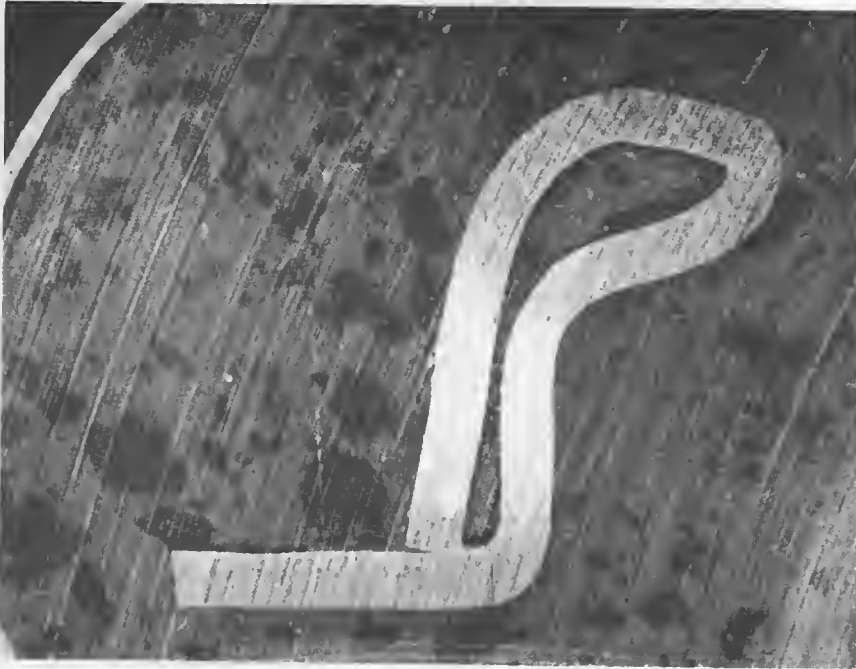
Figure 6

The wheel was fabricated by forming a strip of steel into the cross-section desired (lips formed by bending the strip, Figure 6) and then, in turn, forming this into a circle and butt welding the ends together. The weld flash was removed, presumably by grinding. Chromium plating was done after all mechanical forming and welding was completed.

A Section of the Rim Showing the Final Shape after Forming from Steel Strip. Unetched. Magnification: 5X

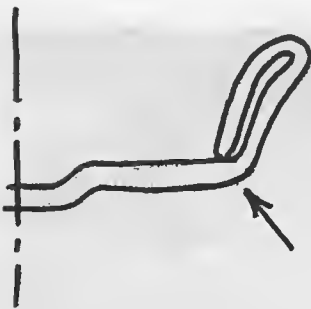
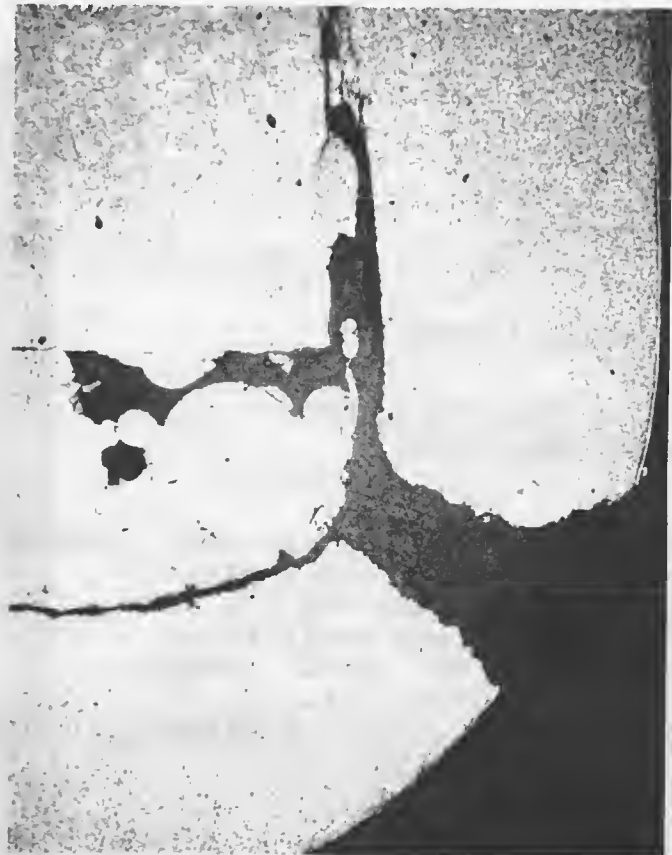
Cross-section of rim at
weld (left or driven side
of wheel where separation
occurred) showing a crack
in the rim. The thin chro-
mium plate can also be seen.
Etched with 2% nital.
Magnification: 35X

1. Metal failure developed at the base of the rim flange due to fatigue, starting at the poor butt weld and progressing circumferentially because of the thinness of the metal and the sharp inner radius, the latter causing stress concentration at this location. Figure 7 shows weld undercutting and poor weld penetration. In addition, the thickness of the steel from which the rim was formed has been reduced, no doubt by the grinding which was performed to remove the welding flash. Further evidence of poor weld quality and the reduction in thickness is shown in Figure 8. In this case, the thickness has been reduced about 40% from the original 49 mils to about 30 mils.

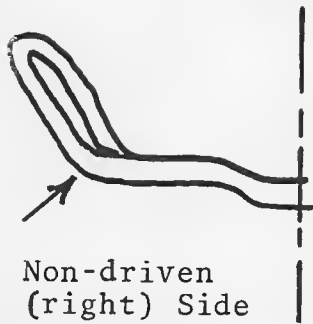
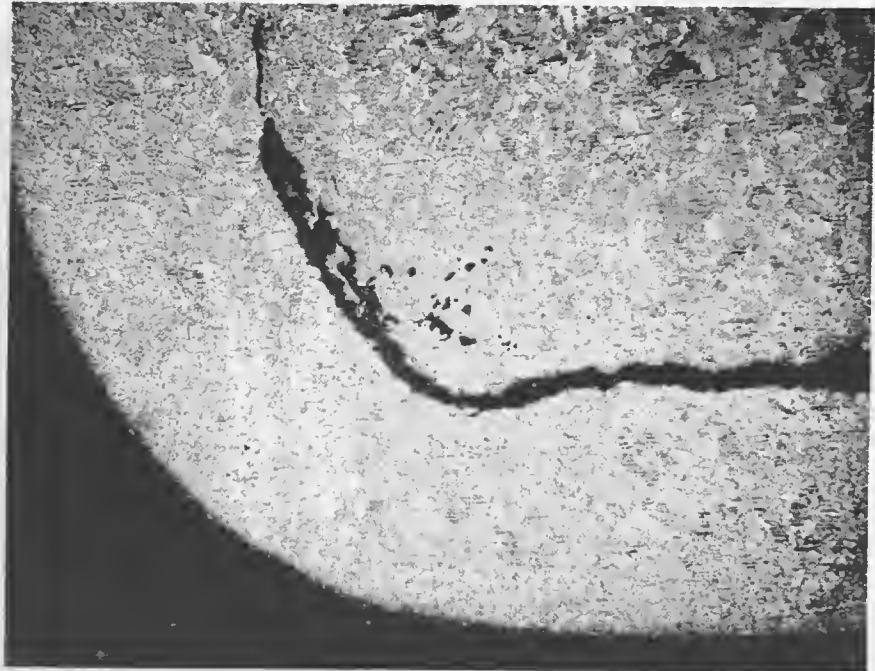
Figure 8

Cross-section of rim at weld (right side, i.e., opposite from Figure 7). There is no evidence of a crack penetration into (or through) the rim. Etched with 2% nital. Magnification: 35X

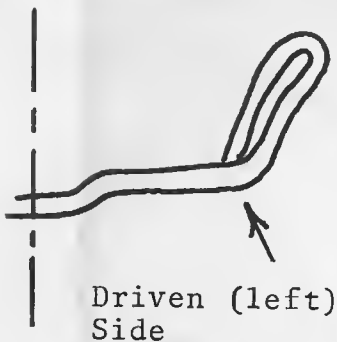
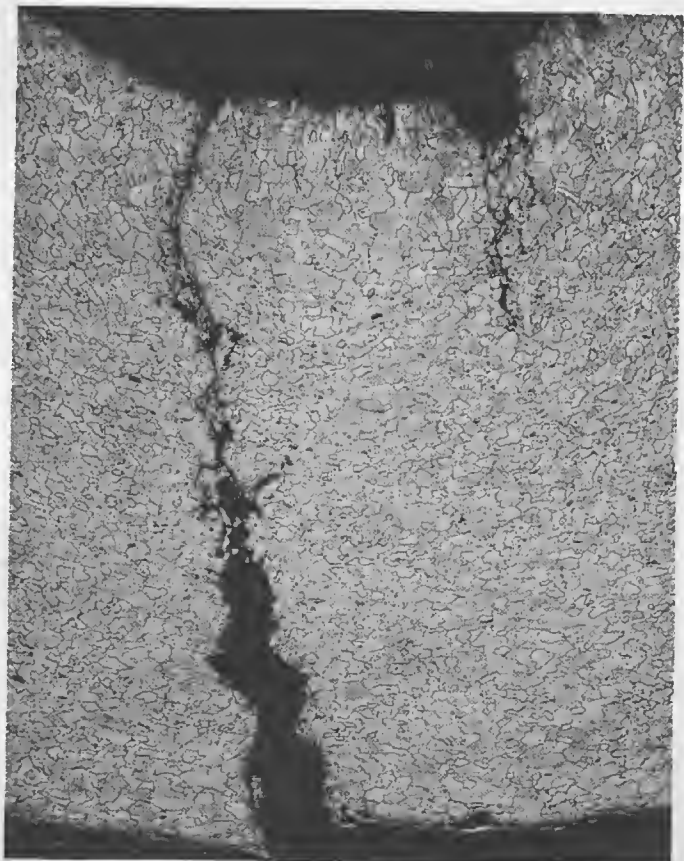
Figure 9

Cross-section of the rim away from the weld showing a primary crack through the rim with a secondary crack progressing outward from the inside radius. The thin chromium plate is obvious. Etched with 2 % nital. Magnification: 35X
